**AN
INVESTIGATION OF INADVERTENT ARMING
OF
MK-82 AND M-117 GENERAL PURPOSE
AND
MK-82 SNAKEYE BOMBS**

TECHNICAL REPORT AFATL-TR-72-73

APRIL 1972

AIR FORCE ARMAMENT LABORATORY

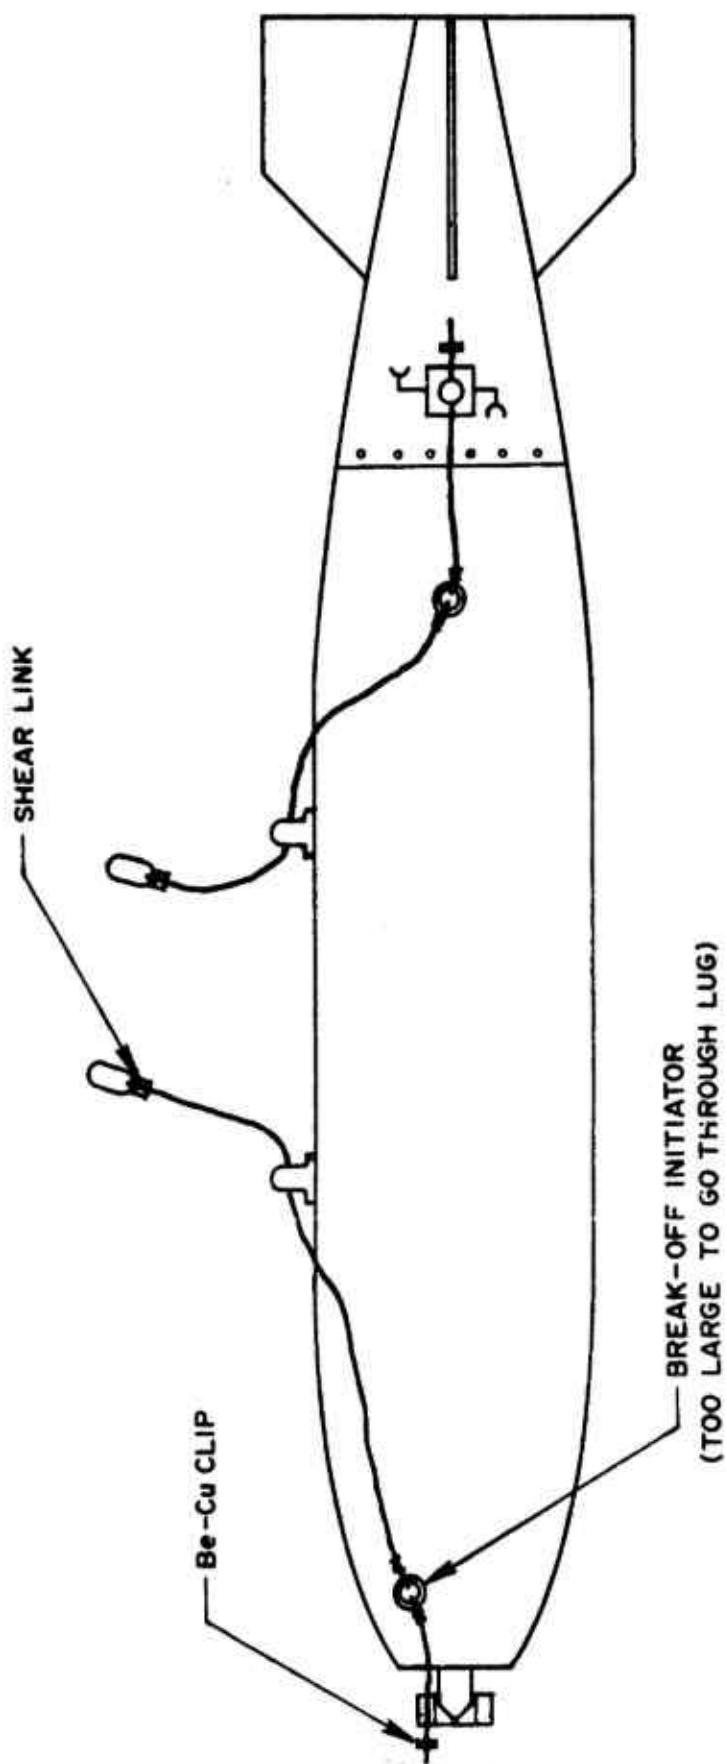
Figure 1. Direct Arming Wire Rigging

Because of the failures which occurred even with the most ideal conditions (small foot and wire on lower side), it was decided that the best solution to the inadvertent arming of GP bombs was direct routing. Direct routing consists of running the arming wire from the nose or tail fuze directly to the nearest solenoid. This solution would eliminate routing the arming wire past the ejector foot where it could hang up, and in addition, would provide a direct 1 to 1 relationship between the tensile force in the arming wire and the force on the solenoid. This relationship would make the force on the clip equivalent to the force on the solenoid so that a 14 pound force (if the solenoid could be assumed to operate reliably as specified) could pull the swivel and link from the solenoid before the clip is stripped from the wire.

The adverse effect of direct routing (the wires remaining on the aircraft) could be eliminated by incorporation of an AFLC/OOAMA proposal (Figure 1). This proposal includes adding a shear link and a break-away initiating component which would hang up on the lug, thus allowing the arming wire to fall away with the bomb.

For the MK-82 and M-117 GP bombs, it would appear that the most feasible solution to the inadvertent arming problem is direct routing. A shear link which will allow the arming wires to separate with the bomb should be fabricated and tested (both in the safe and armed mode) and, if successful, should be used to eliminate banjo rigging. Flight tests should be conducted to insure that any piece added to cause the wire to shear will not be subject to flutter in the slipstream because this could extract the arming wire.
